Review of Environmental Factors

Hunter-Central Coast REZ Network Infrastructure

Appendix H - Contamination Reports

Report on
Preliminary Site Investigation (Contamination)

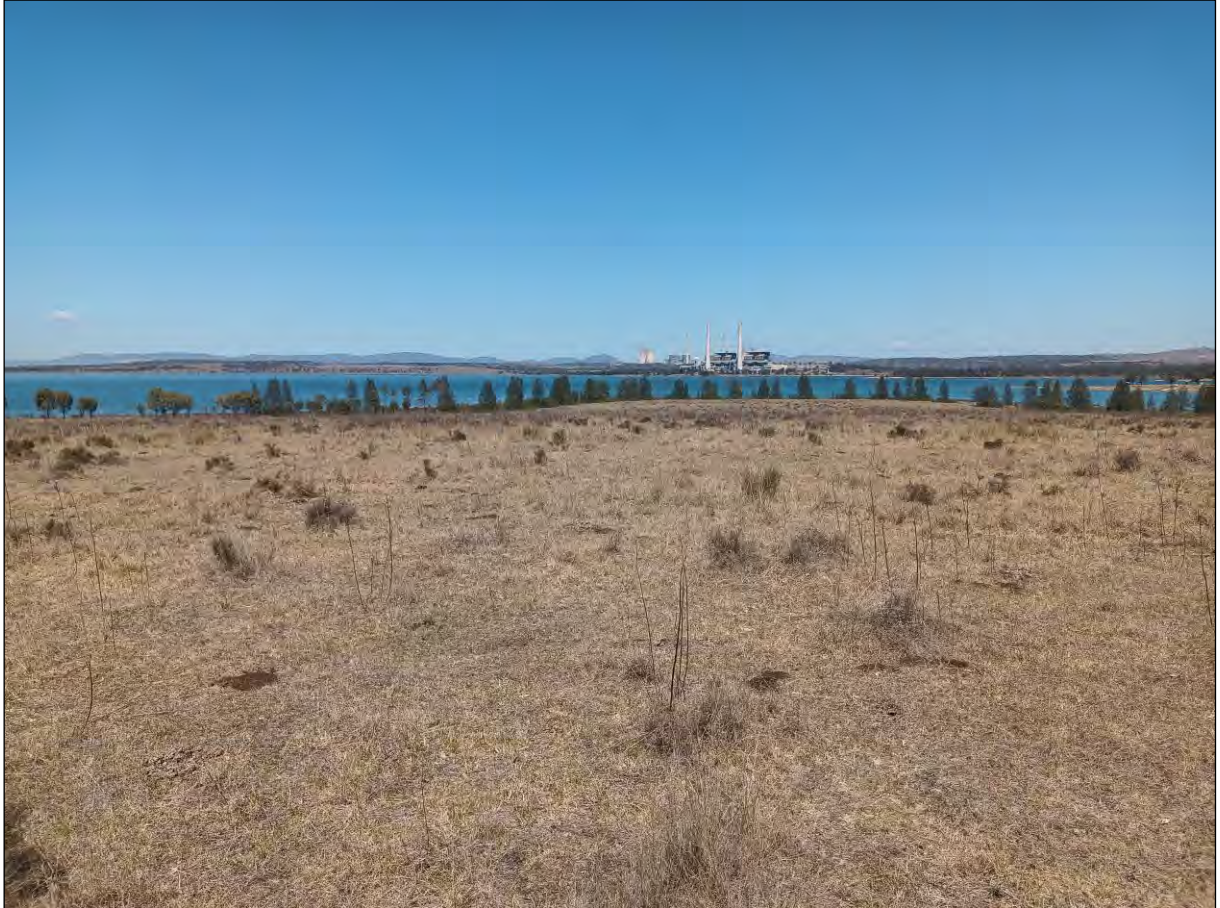
Photograph E1: Looking south-west from the central portion of the site

A site walkover was conducted by a DP environmental engineer on 25 September 2023. The general site topography was consistent with that described in Section 5. The site layout appears to have remained unchanged from the 2023 aerial photograph. The following key site features pertinent to the PSI were observed (refer to photographs provided in Appendix E).

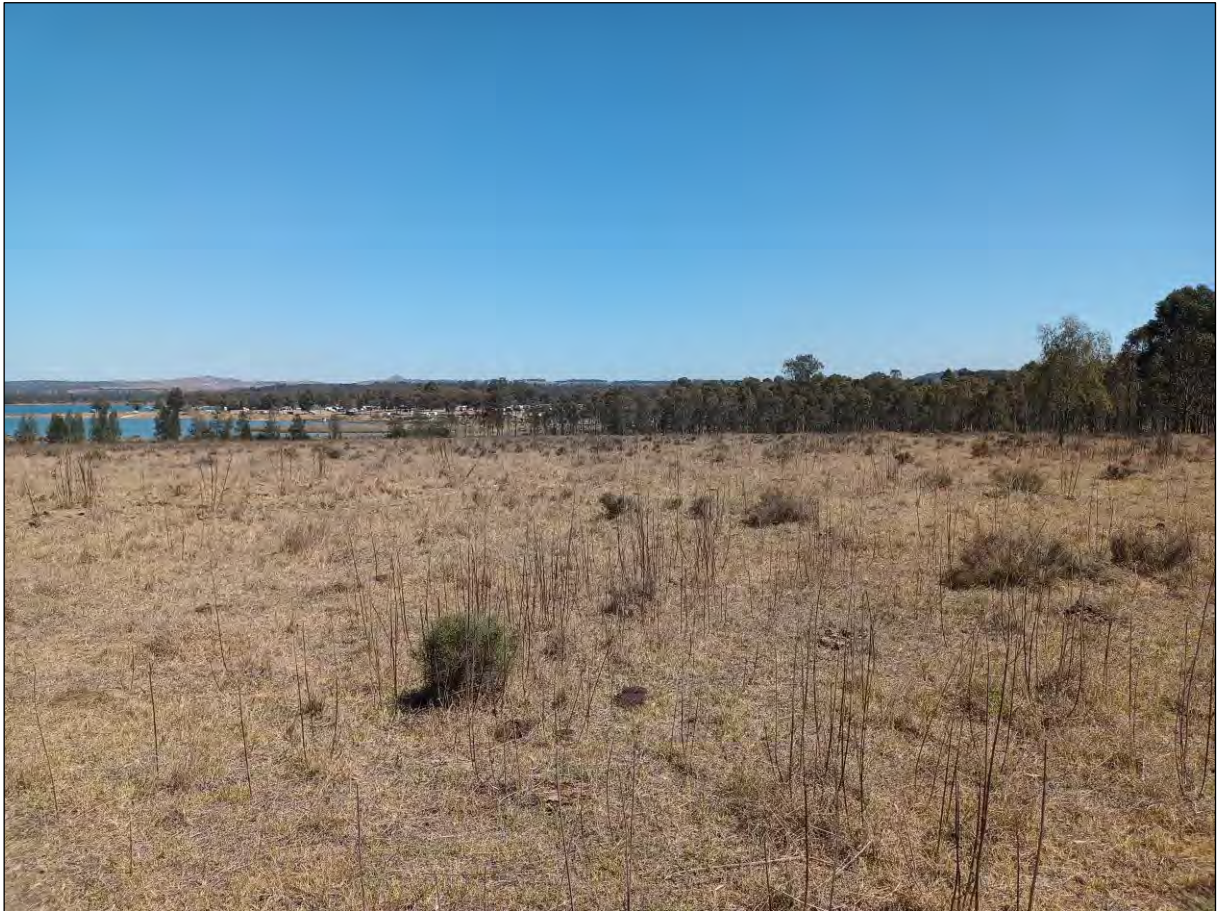
Photograph E2: Looking west from the central portion of the site towards mature trees to the west of the site

Mature trees were observed in the north-western portion of the site (Photograph E2). Hebden Road was located immediately north of the northern site boundary (Photograph E3)

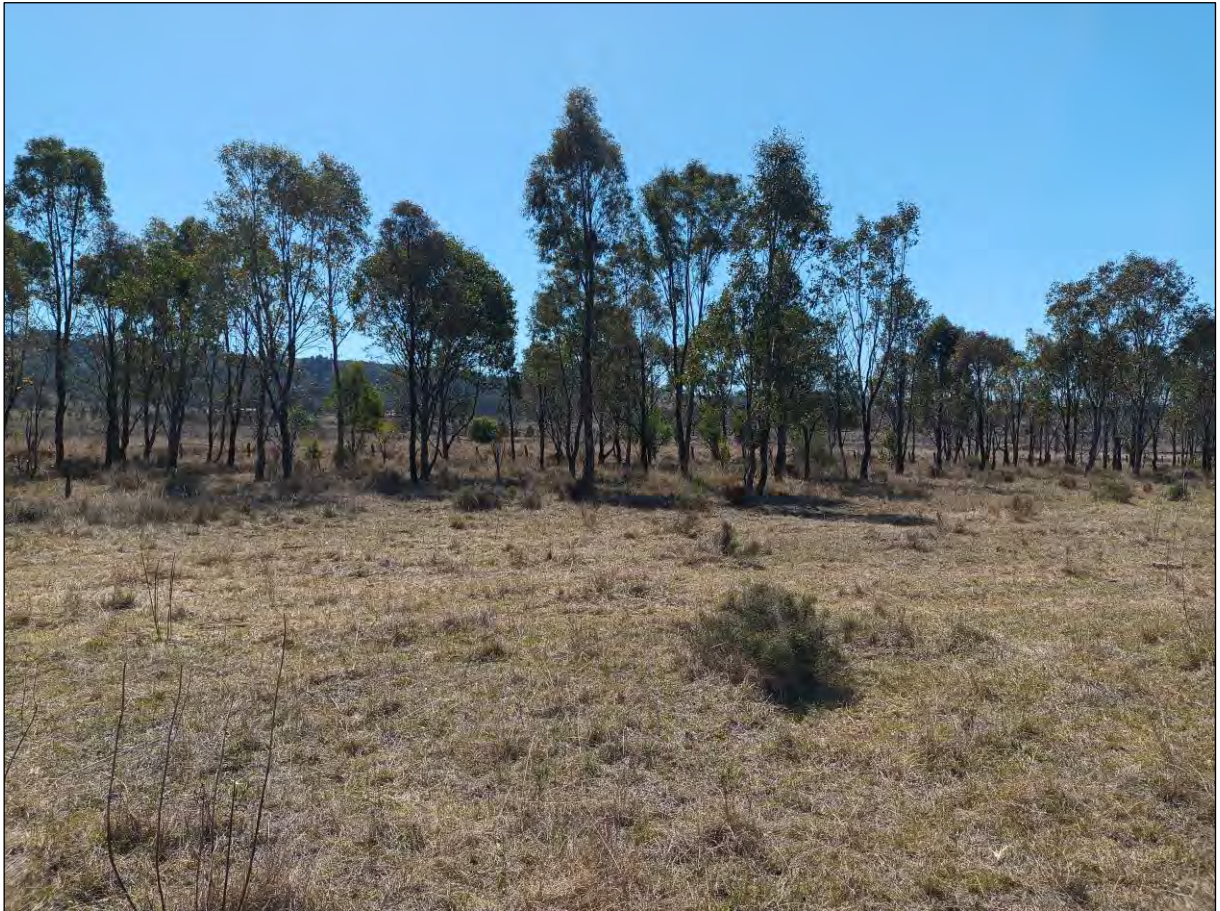
Photograph E3: Northern boundary and Hebden Road (behind trees) in the northern portion of the site

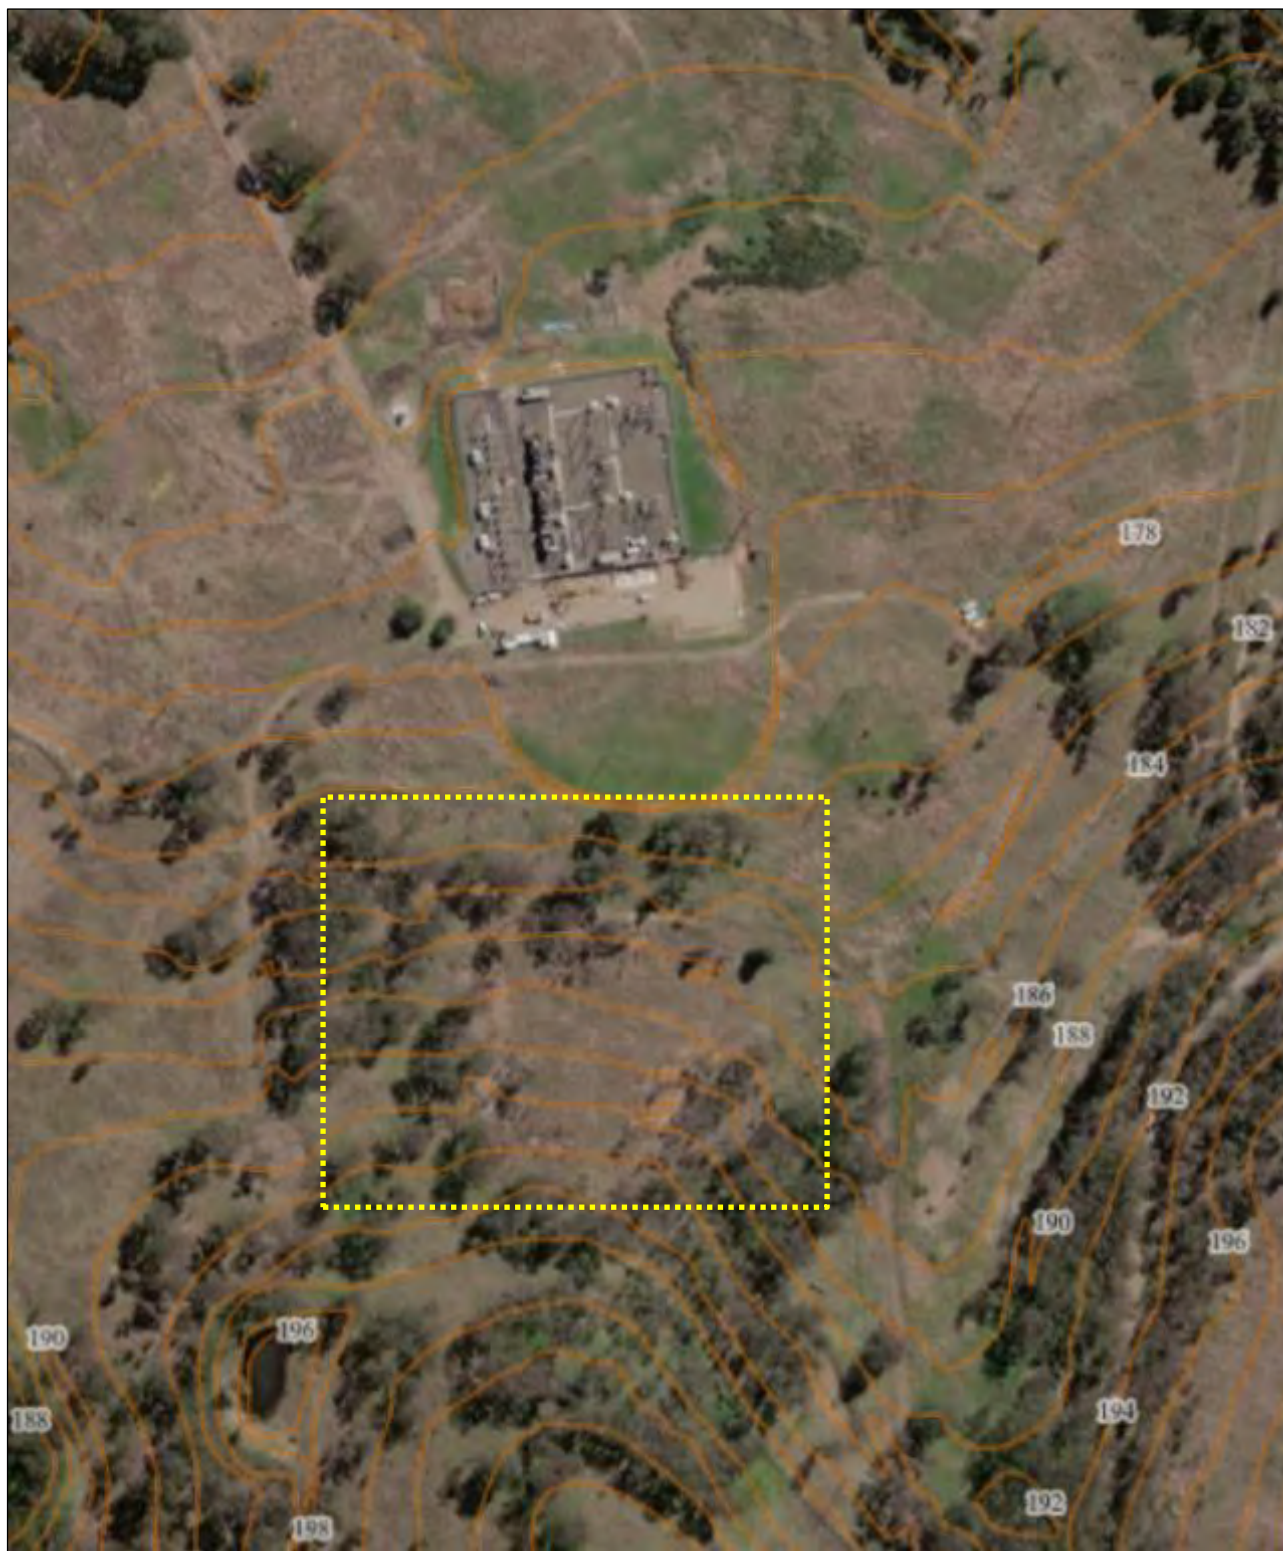
Figure 2: Site topography (approximate extent of site in yellow)

Based on the regional topography and the inferred flow direction of nearby water courses, the anticipated flow direction of groundwater beneath the site is to the west, towards Sandy Creek, the likely receiving surface water body for the groundwater flow path.

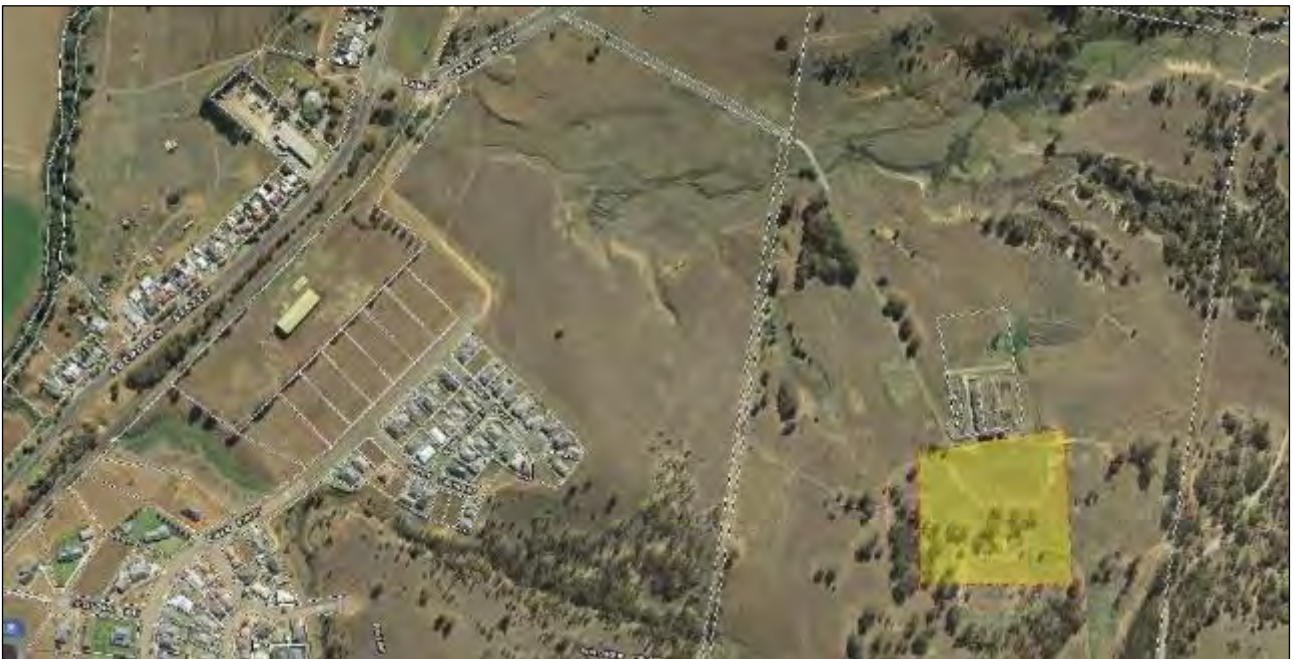
Figure 3: Approximate location of former investigation area (yellow)

The investigation area included the northern portion of the current site area, plus an additional area to the north, which was found to be the location of a former small power station. The approximate location of the previous assessment is shown in Figure 3.

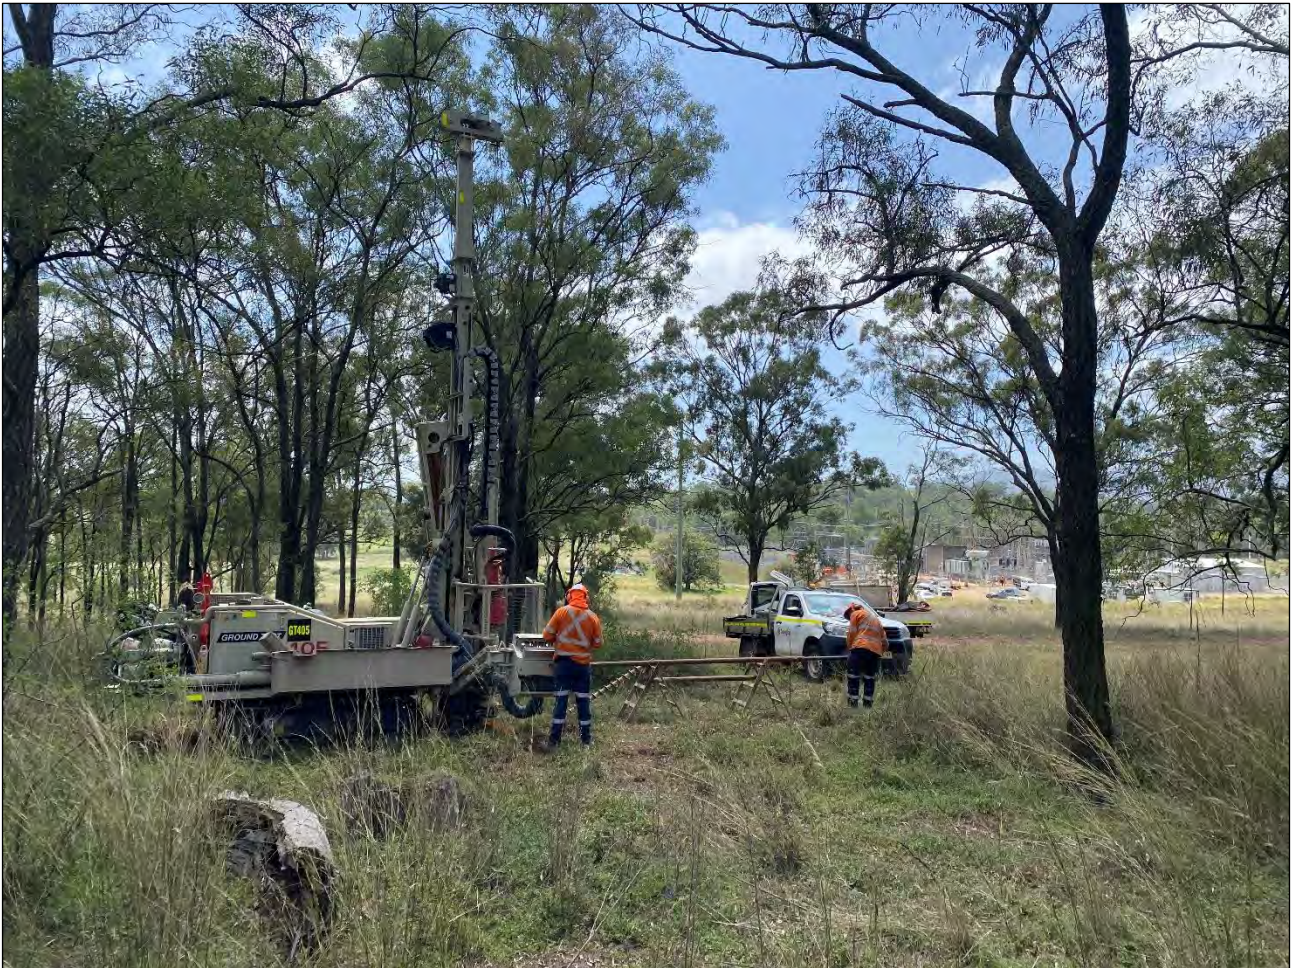
Photograph F1: looking north-east from the western portion of the site, with the site falling to the north (existing substation in background)

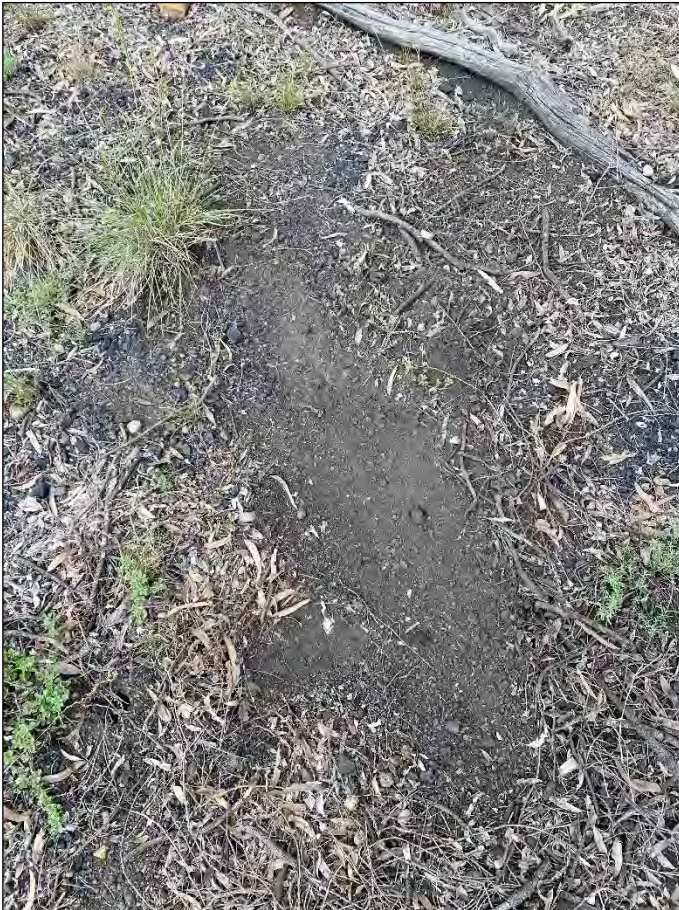
Photograph F2: Possible ash and coal gravel at the site surface, generally in the eastern portion of the site

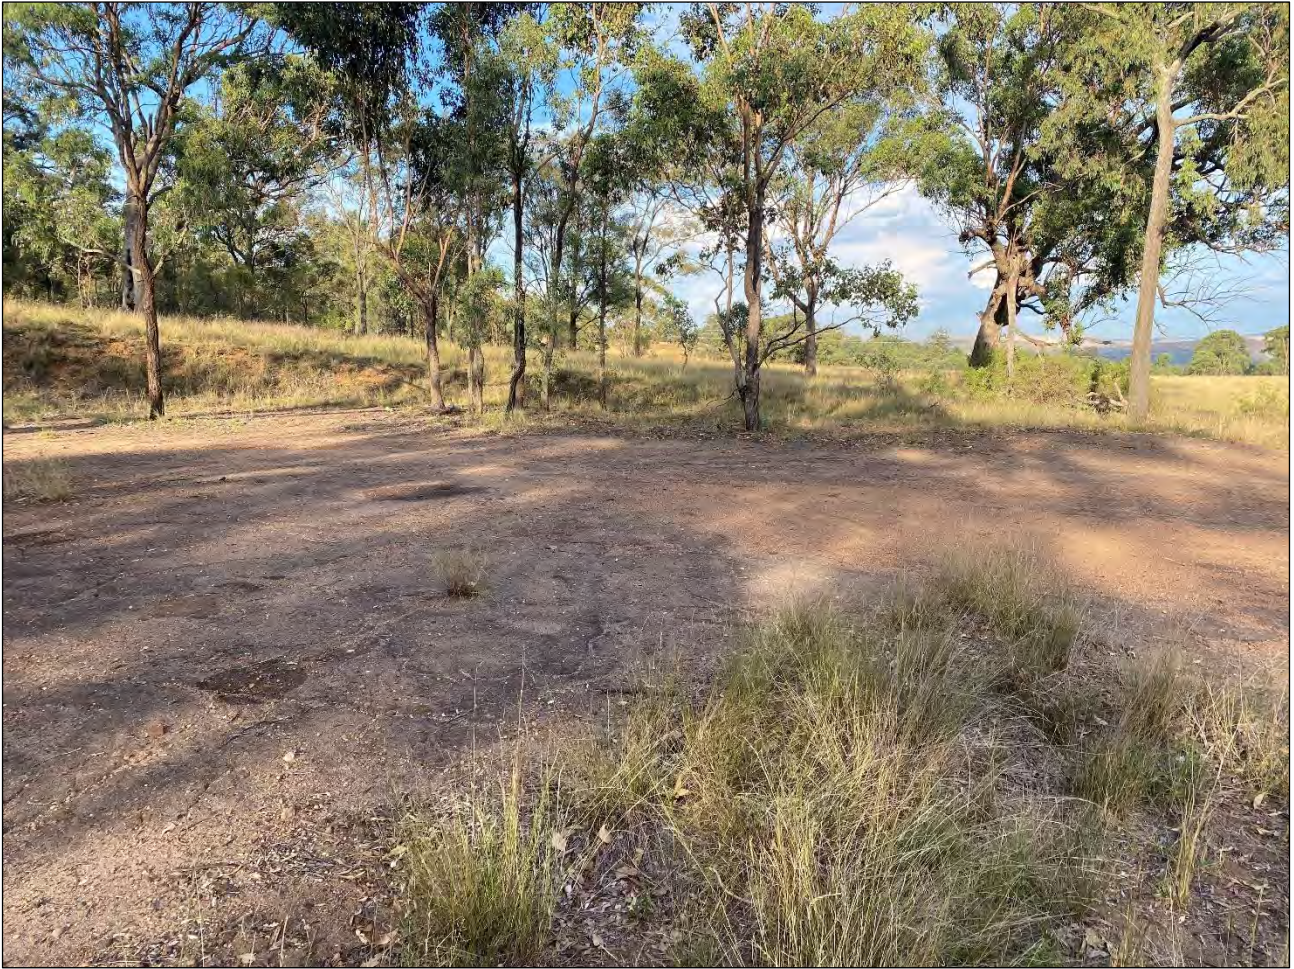
Photograph F3: levelled area in the southern portion of the site, looking west

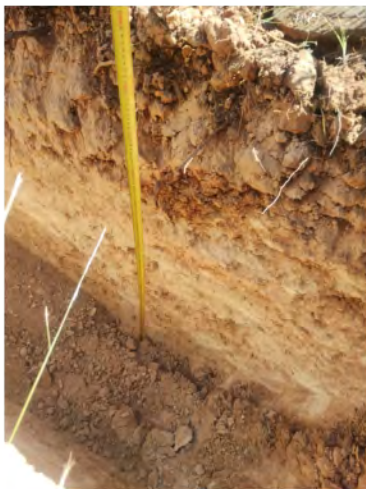
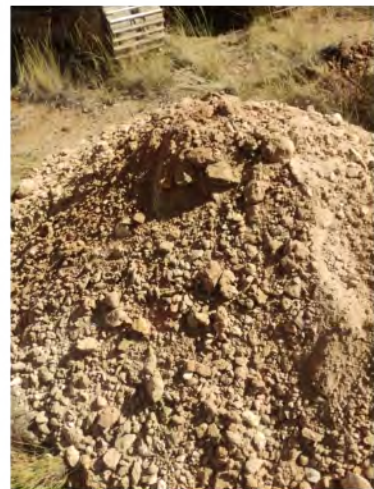
Pit 313

CONDITIONS ENCOUNTERED														SAMPLE			TESTING AND REMARKS		
GROUNDWATER	RL (m)	DEPTH (m)	DESCRIPTION OF STRATA	GRAPHIC	ORIGIN (#)	CONSIS. ^(*)	DENSITY. ^(*)	MOISTURE	REMARKS	TYPE	INTERVAL	DEPTH (m)	TEST TYPE	RESULTS AND REMARKS					
12/03/24 No free groundwater observed	186	0.30	FILL / Sandy CLAY (CL), with silt, with gravel: mottled red orange; low plasticity; fine to medium sand; fine to medium, sub-angular to sub-rounded gravel; with organics, rootlets; trace coal fines.		FILL	NA	w<PL			D/ES		0.20	PID	<1ppm					
		RS	H		w<PL	D/ES				0.80	PID PP	<1ppm >400kPa							
		RS	H		w<PL	D/ES				1.50	PID PP	<1ppm >400kPa							
	185	2	Test Pit discontinued at 1.70m depth. Limit of investigation. Solid rock encountered..											2					
		3												3					
		4												4

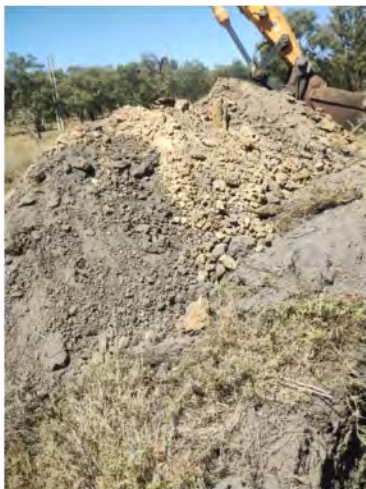
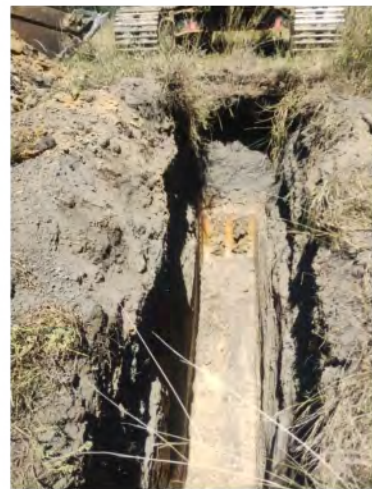
Pit 318

1.10	FILL / Clayey SAND (SC), with gravel: brown; fine to medium; fine to medium, sub-angular to sub-rounded gravel; trace coal fines, ash, slag.							D/ES	1.50
		CLAY (CL): mottled orange brown; low plasticity.								
	2			RS possibly XWM	H		w<PL			
Test Pit discontinued at 2.60m depth. Limit of investigation. Solid rock encountered..										
	3									
	4
